SERVICE BULLETIN**N° 169-148****EMERGENCY ALERT****DATE:** May 29, 2019**REV. :** B - February 4, 2020

TITLE**ATA 64 - TAIL ROTOR FLIGHT CONTROL IMPROVED PERIODICAL INSPECTION****REVISION LOG**

This Service Bulletin is issued in order to require the periodical inspection of the slippage marking of the back-end castellated nut of the TR servo-actuator and the periodical detailed inspection of the TR duplex bearing.

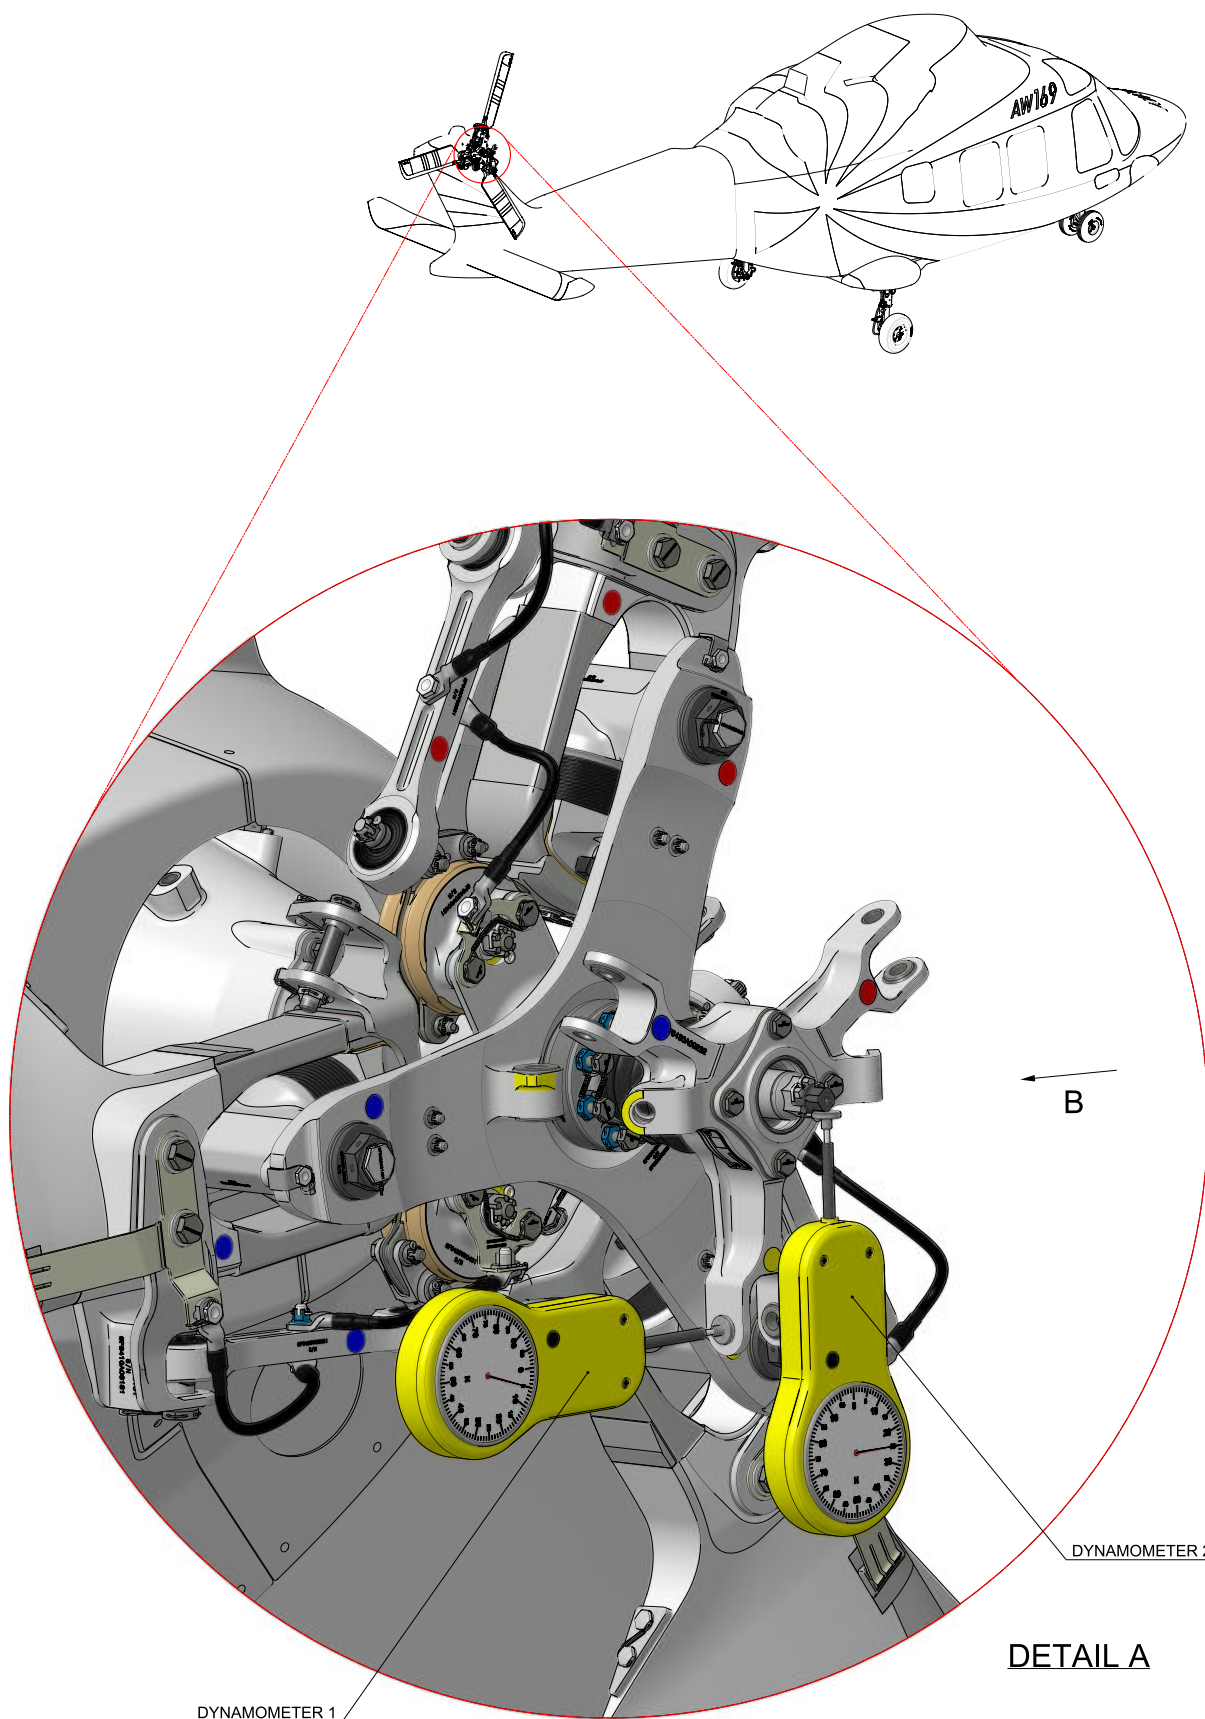
With reference to Figure 1 and Figure 2 View B and Detail C, apply a 25 ± 2.5 N upward force on the squared rod end by means of a dynamometer while performing the instructions reported in steps from 7.3 to 7.7. It is allowed to apply the force either pushing or pulling the rod end with the dynamometer.

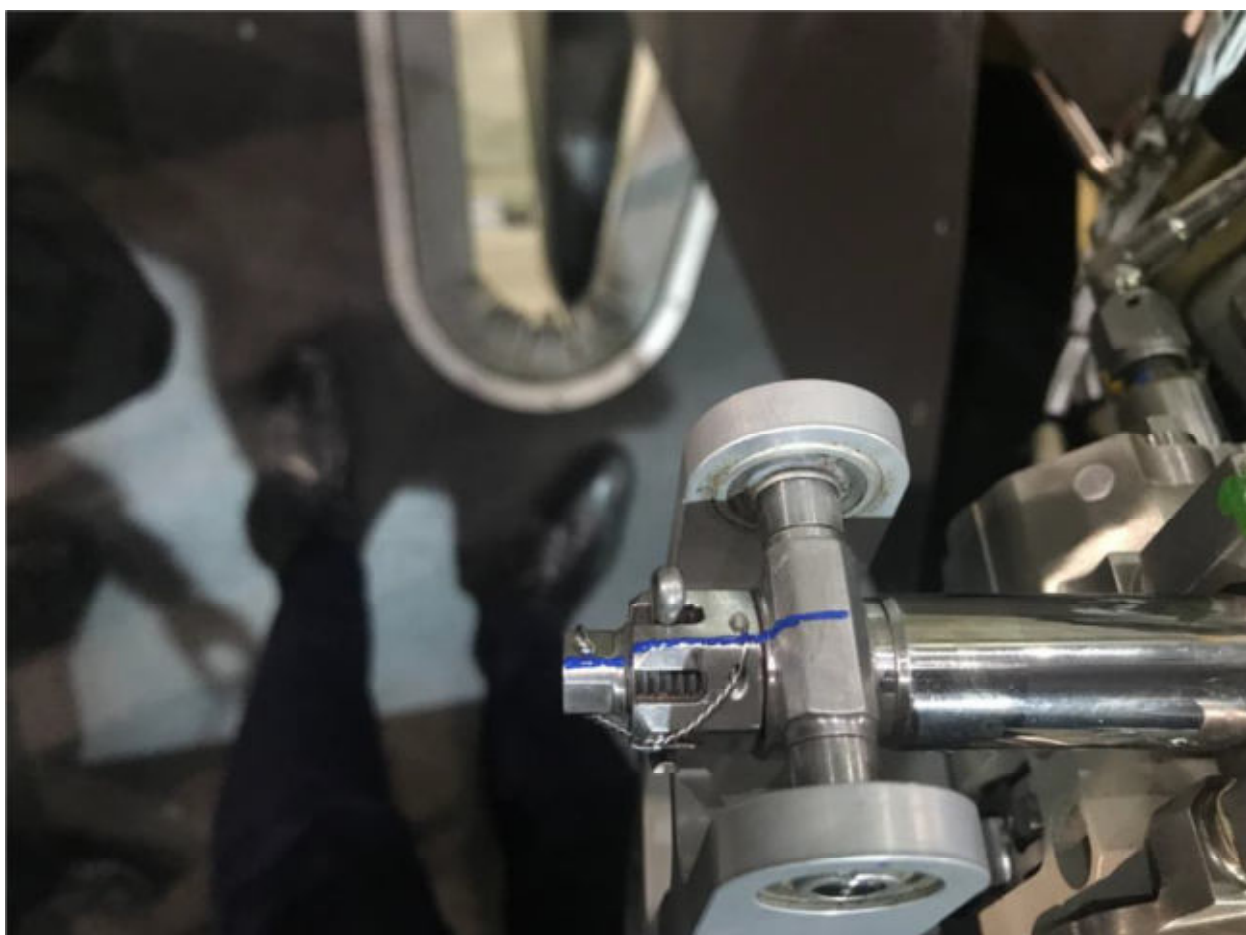
Figure 3

4. With reference to Figure 3, check the slippage mark on the castellated nut for absence of evidence of rotation between the parts. Record the result on Table I (refer to Figure 7).

- 10.1.5 In accordance with AMP DM 69-A-64-31-04-00A-720A-A, reinstall the sliding control assy.
- 10.1.6 With reference to Figure 3, restore the slippage marking on the castellated nut from the hinge bracket element to the rod.

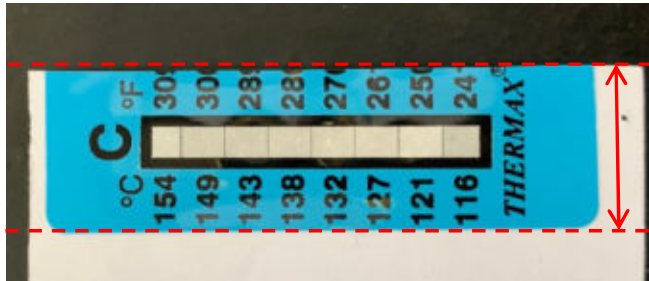
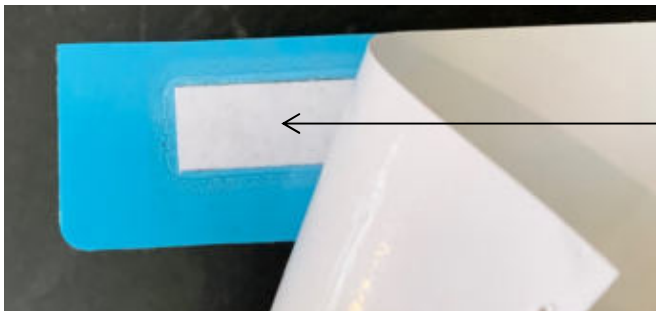
Cutting line. Pay attention to not cut the degree Celsius scale.

Limit cutting at the minimum required to obtain 16mm of height.

Pay attention to not damage or to expose to the environment the sensitive elements.

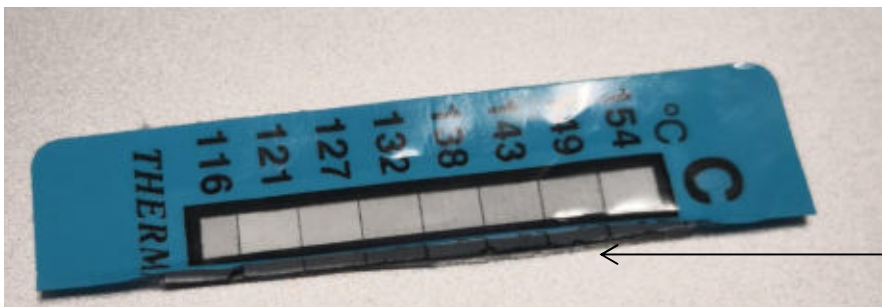
Figure 5

Do not use a thermal strip if after having trimmed it, its sensitive element is exposed to air. See below an example of a badly cut strip.

Thermal strip layers delamination.
NOT acceptable.

If thermal strip trimming is required, confirm that the cut did not cause debonding of strip layers.
